# BOLTED FIELD REPAIR OF COMPOSITE STRUCTURES

J. C. Watson, et al.  
McDonnell Douglas Corporation  
McDonnell Aircraft Company  
P.O. Box 516  
St. Louis, Missouri 63166

Final Report

Repairs were demonstrated on both laminate thicknesses. The 3/16 inch laminate was typical of an AV-8B wing skin. The 1/2 inch laminate was typical of an F-18 wing skin. Three sizes of damage holes were investigated for each laminate thickness: 1.0 in., 2.5 in., and 4.0 in. diameters. Two repair concepts were evaluated for each damage configuration.

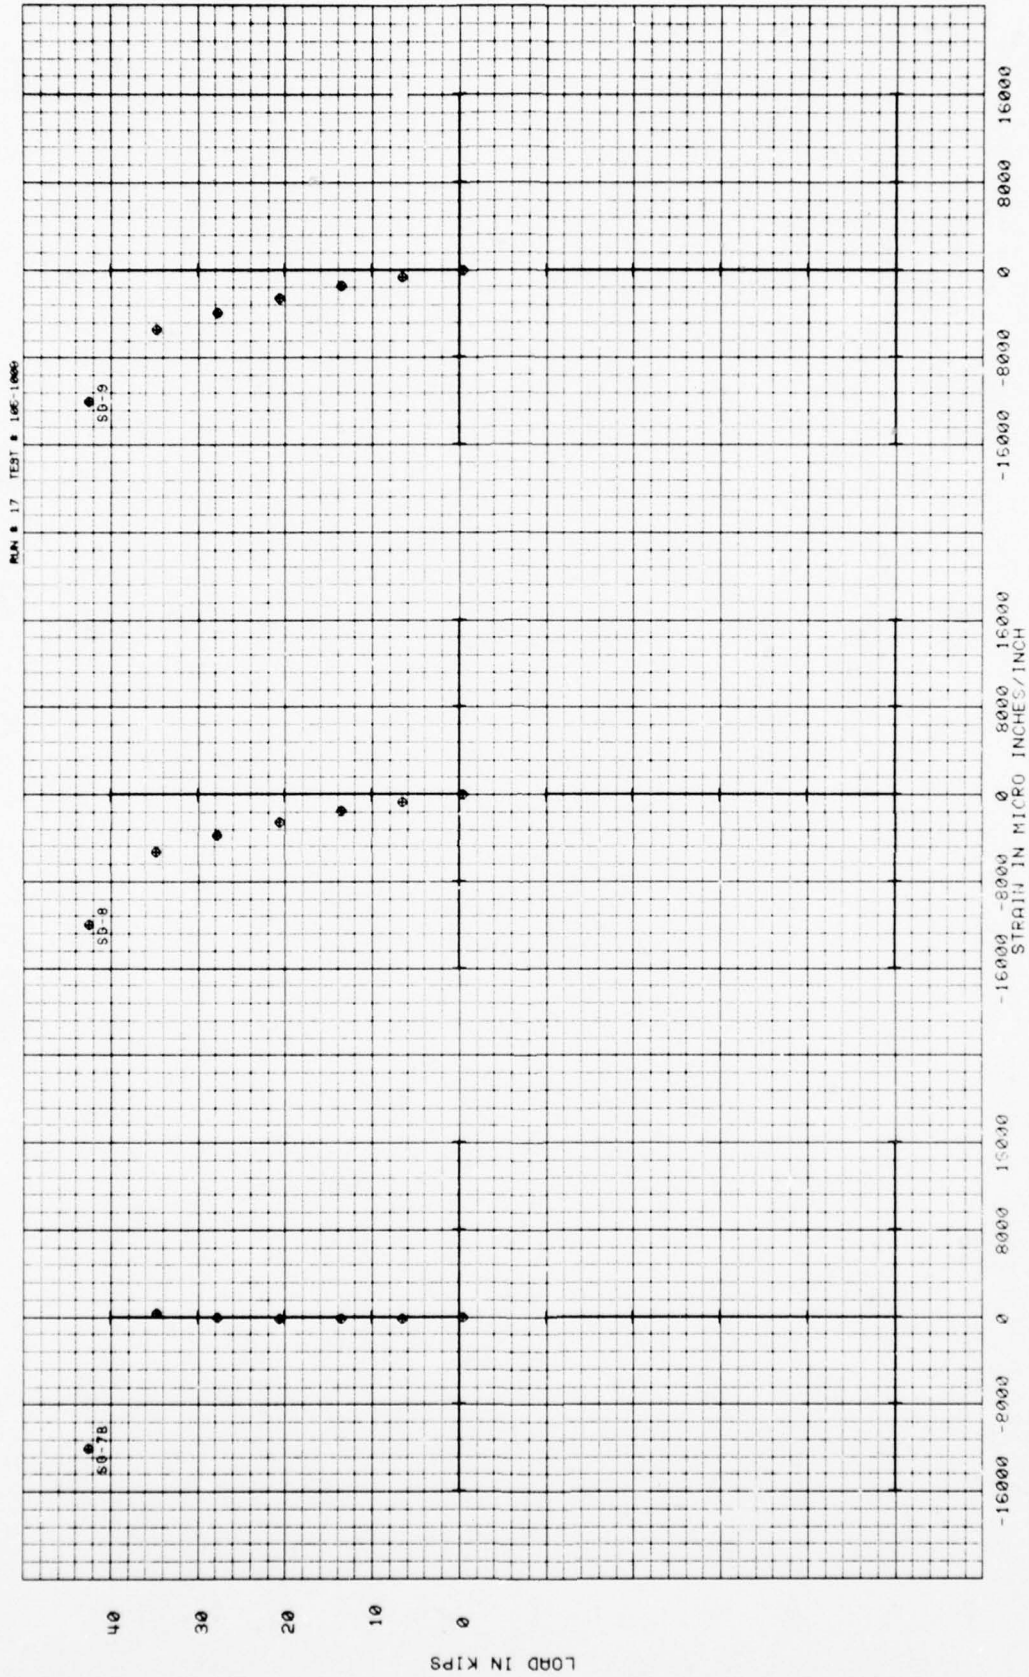
FIGURE B-14 Continued Strain Gage Data 75T060105-1009  
3/16 Laminate Compression

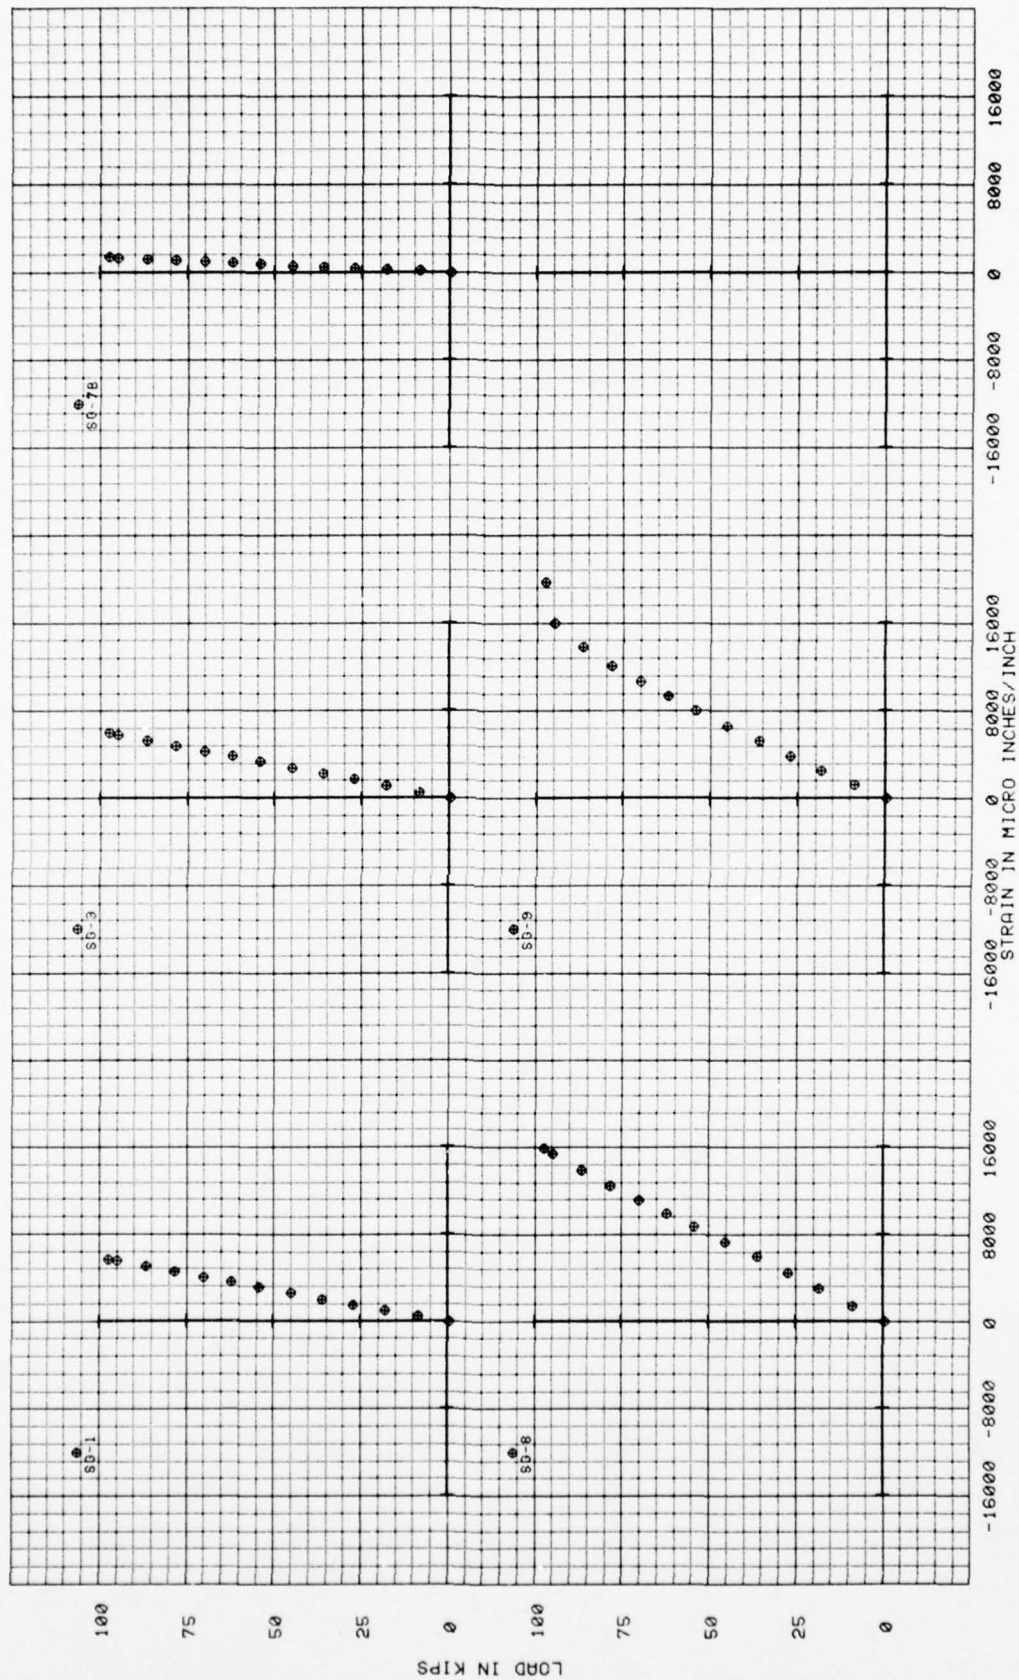
FIGURE B-15 Strain Gage Data 75T060106-1019  
1/2 Laminate 1.0 Dia Damage Hole

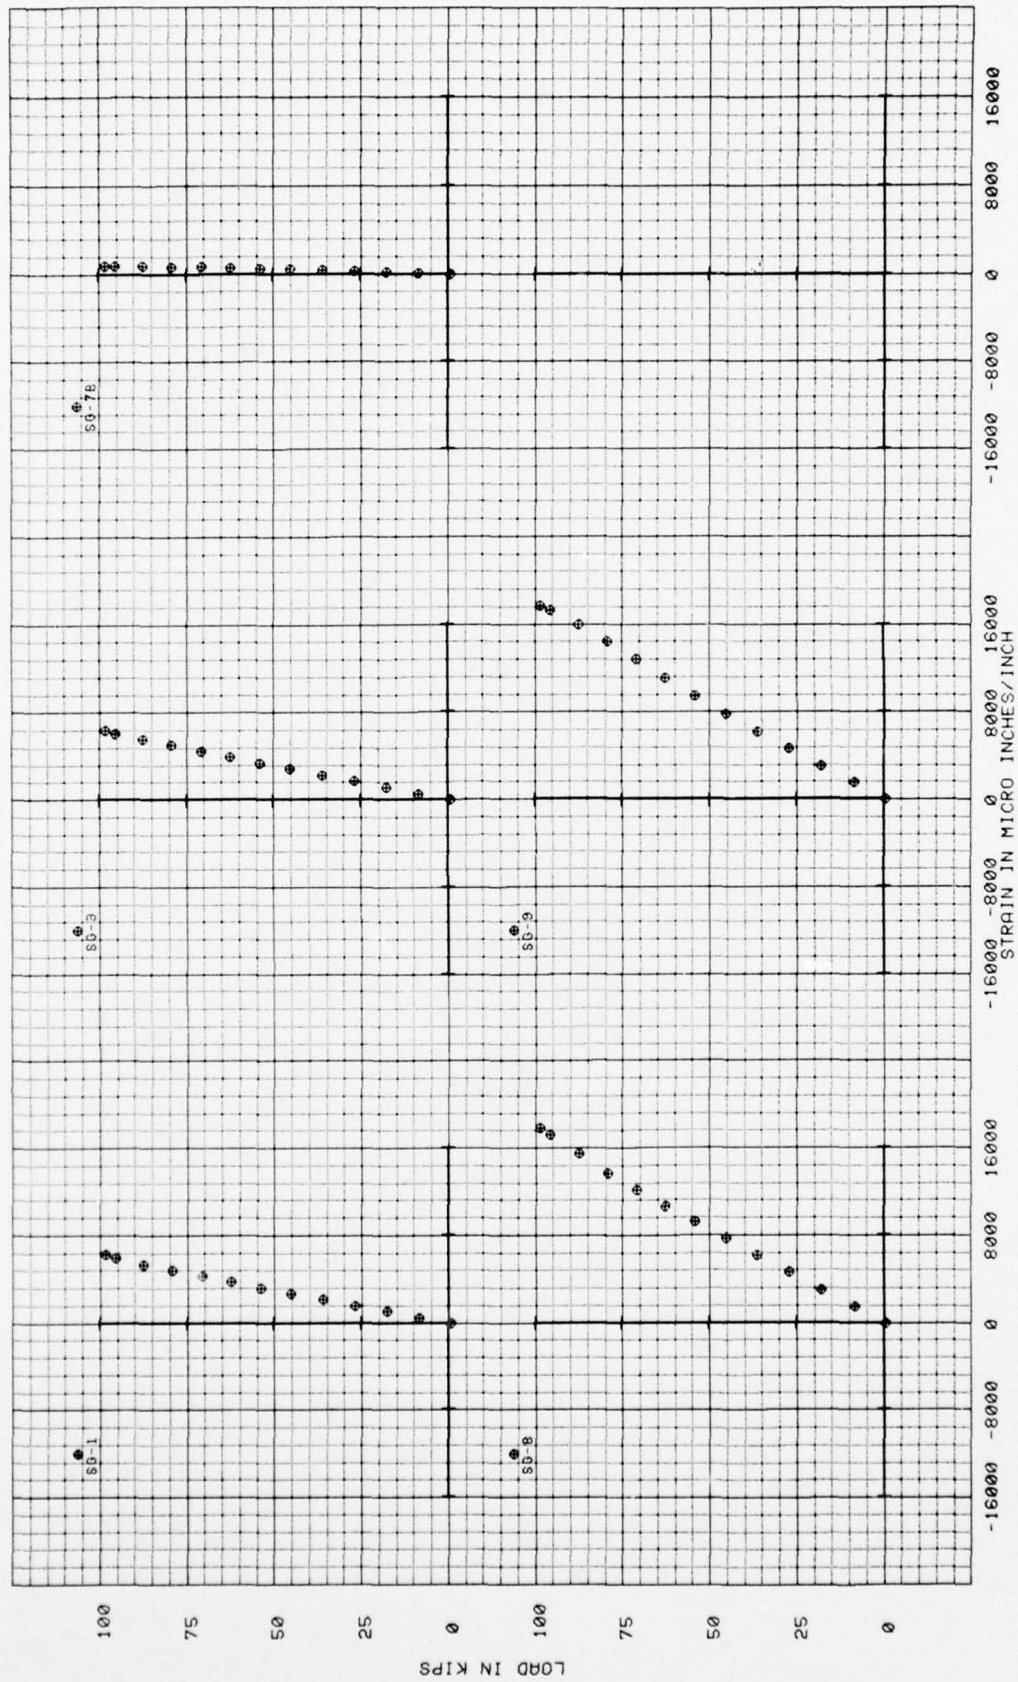
FIGURE B-16 Strain Gage Data 75T060106-1021 No. 1  
1/2 Laminate 1.0 Dia Damage Hole

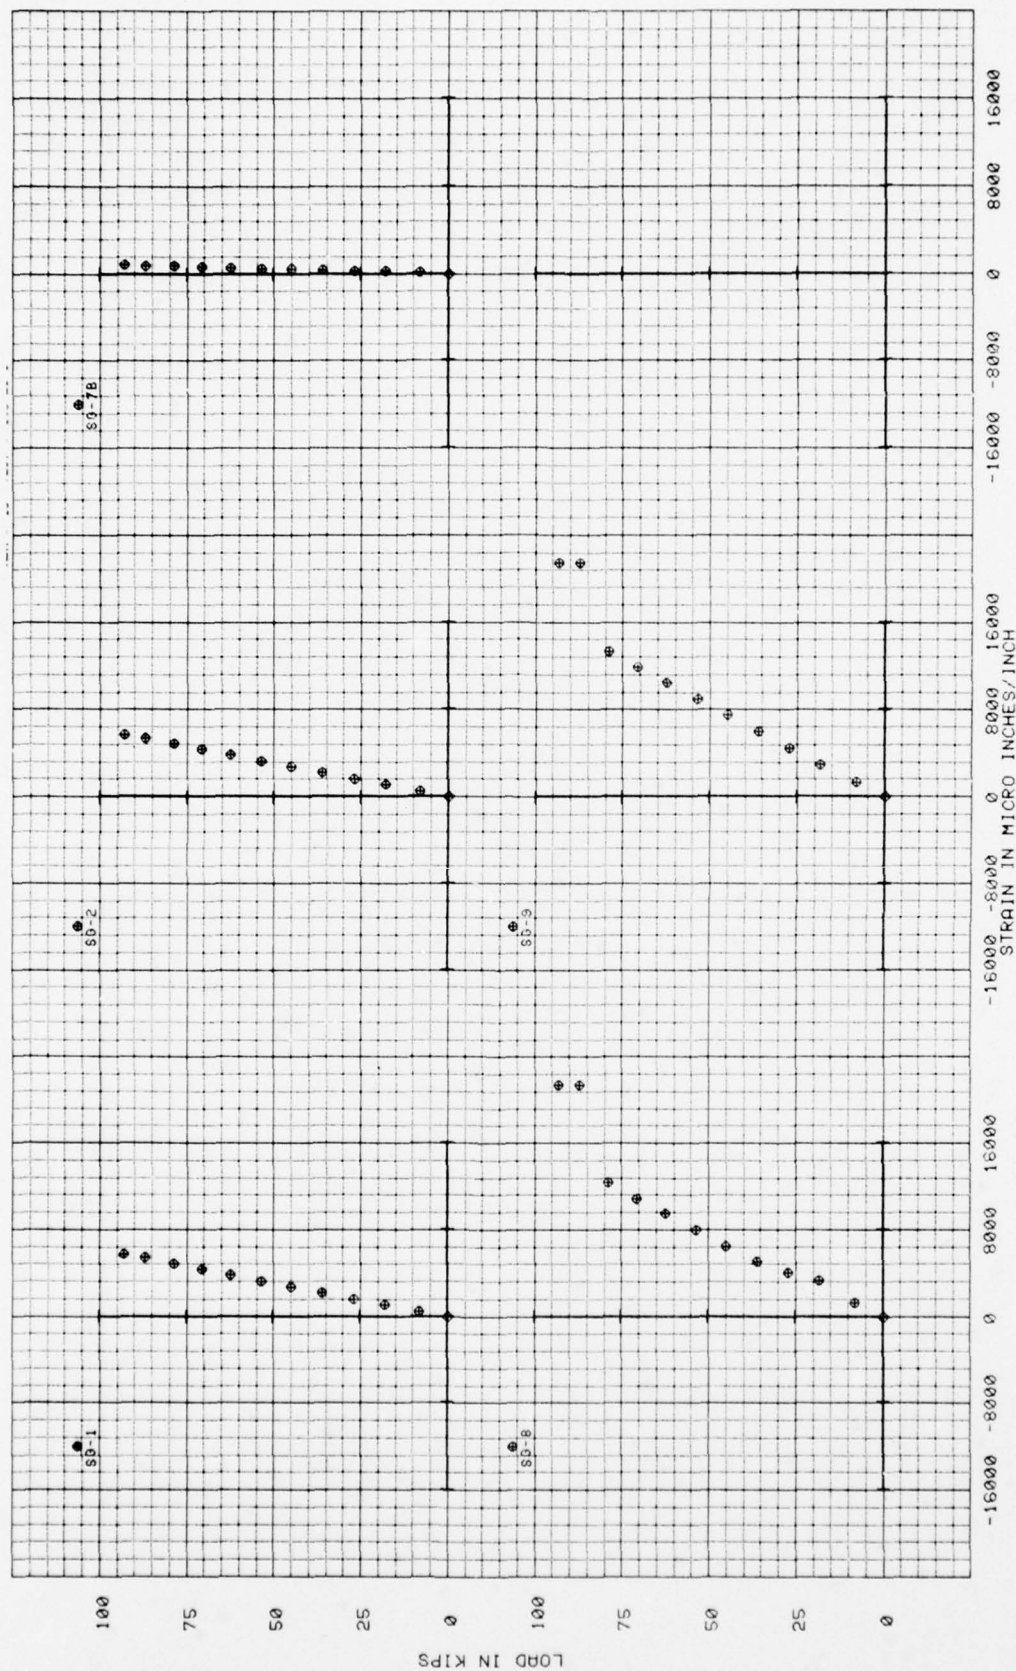
FIGURE B-17 Strain Gage Data 75T060106-1021 No. 2  
1/2 Laminate 1.0 Dia Damage Hole

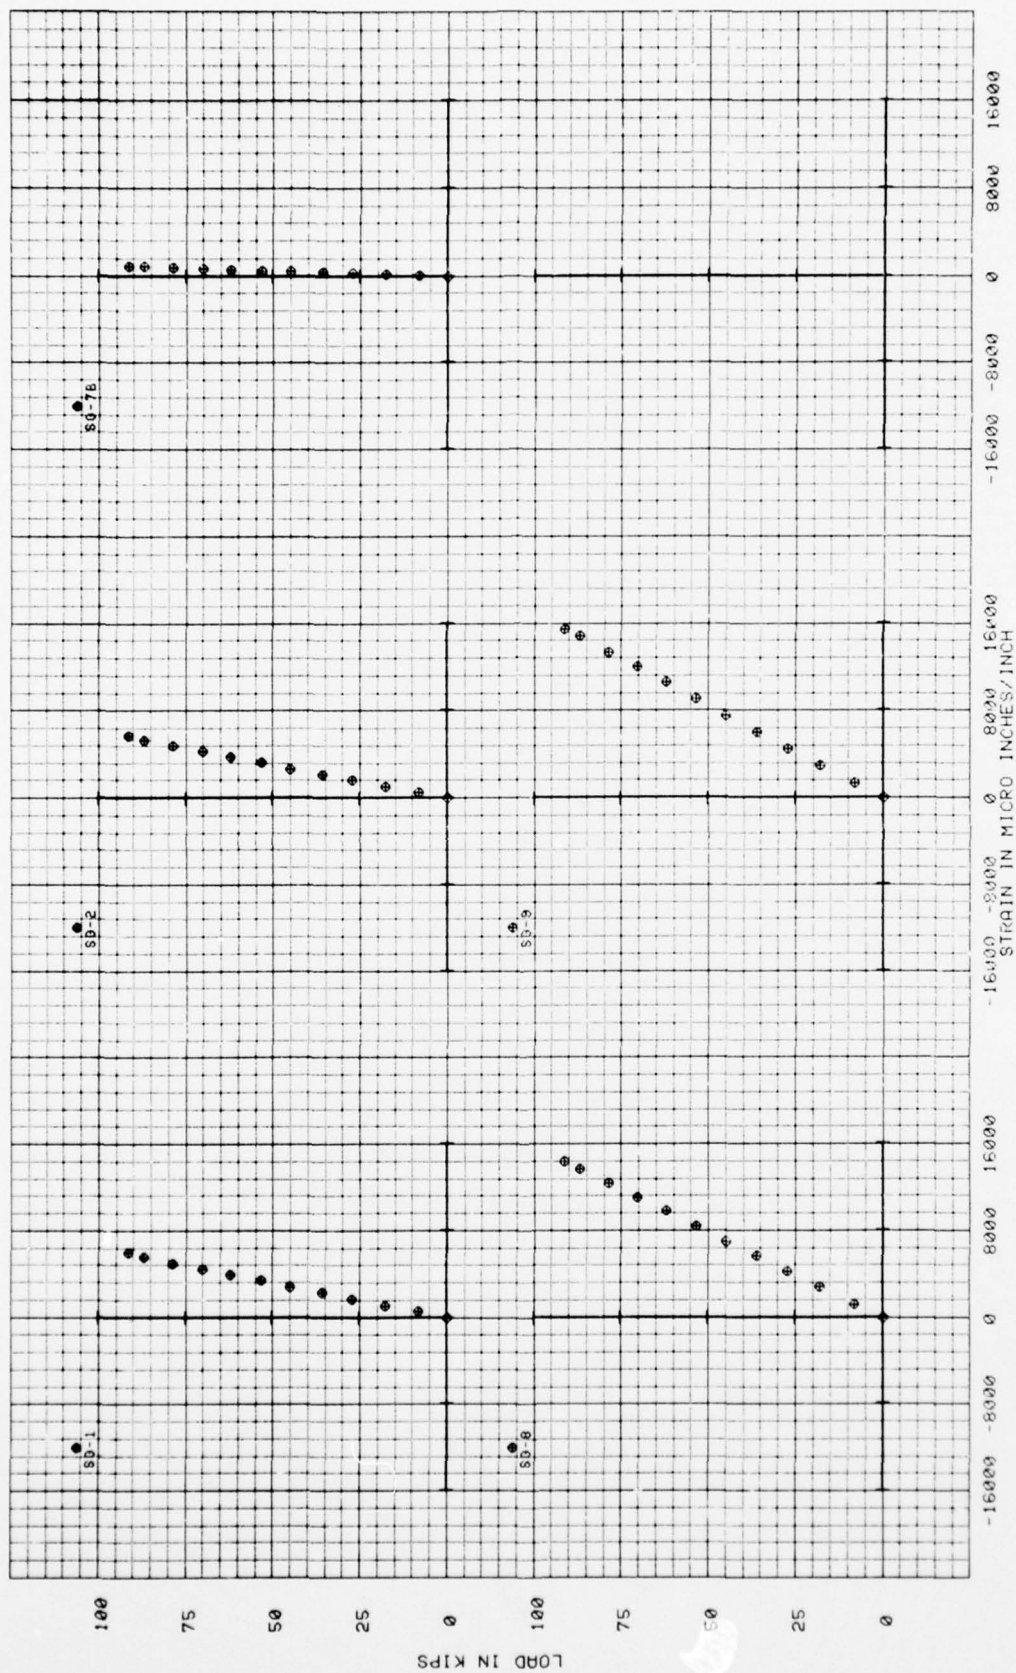
FIGURE B-18 Strain Gage Data 75T060106-1021 No. 3  
1/2 Laminate 1.0 Dia Damage Hole

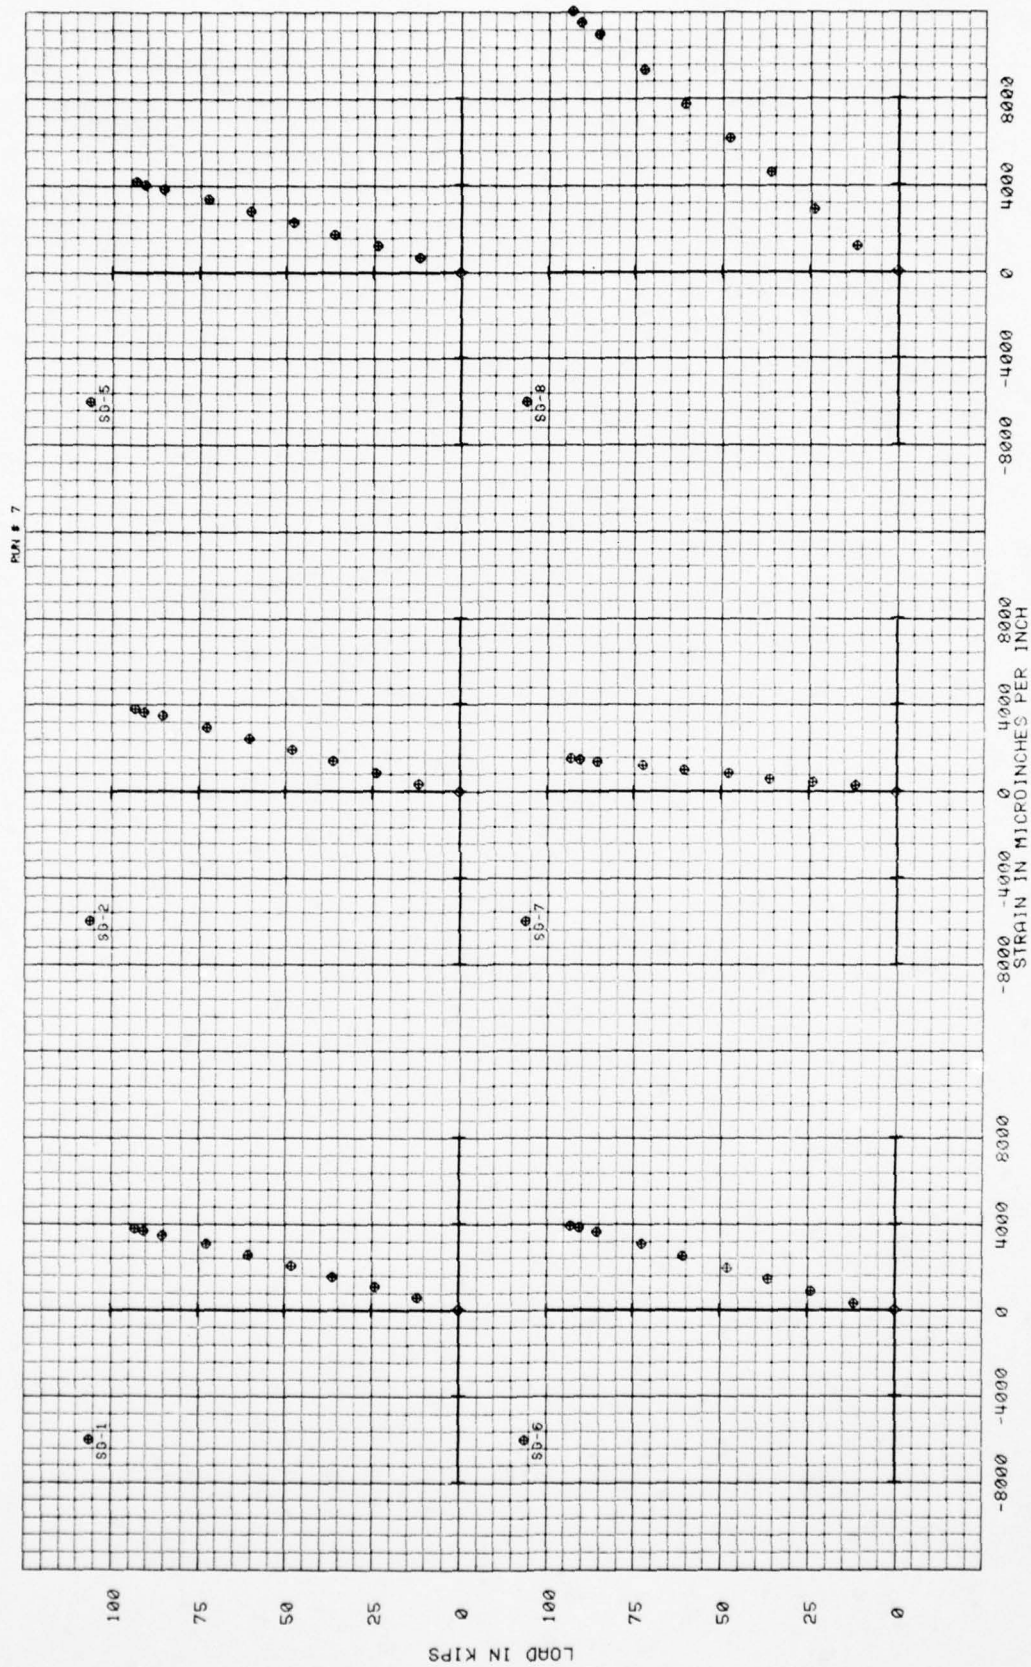
FIGURE B-19 Strain Gage Data 75T060106-1005  
1/2 Laminate 2.5 Dia Damage Hole

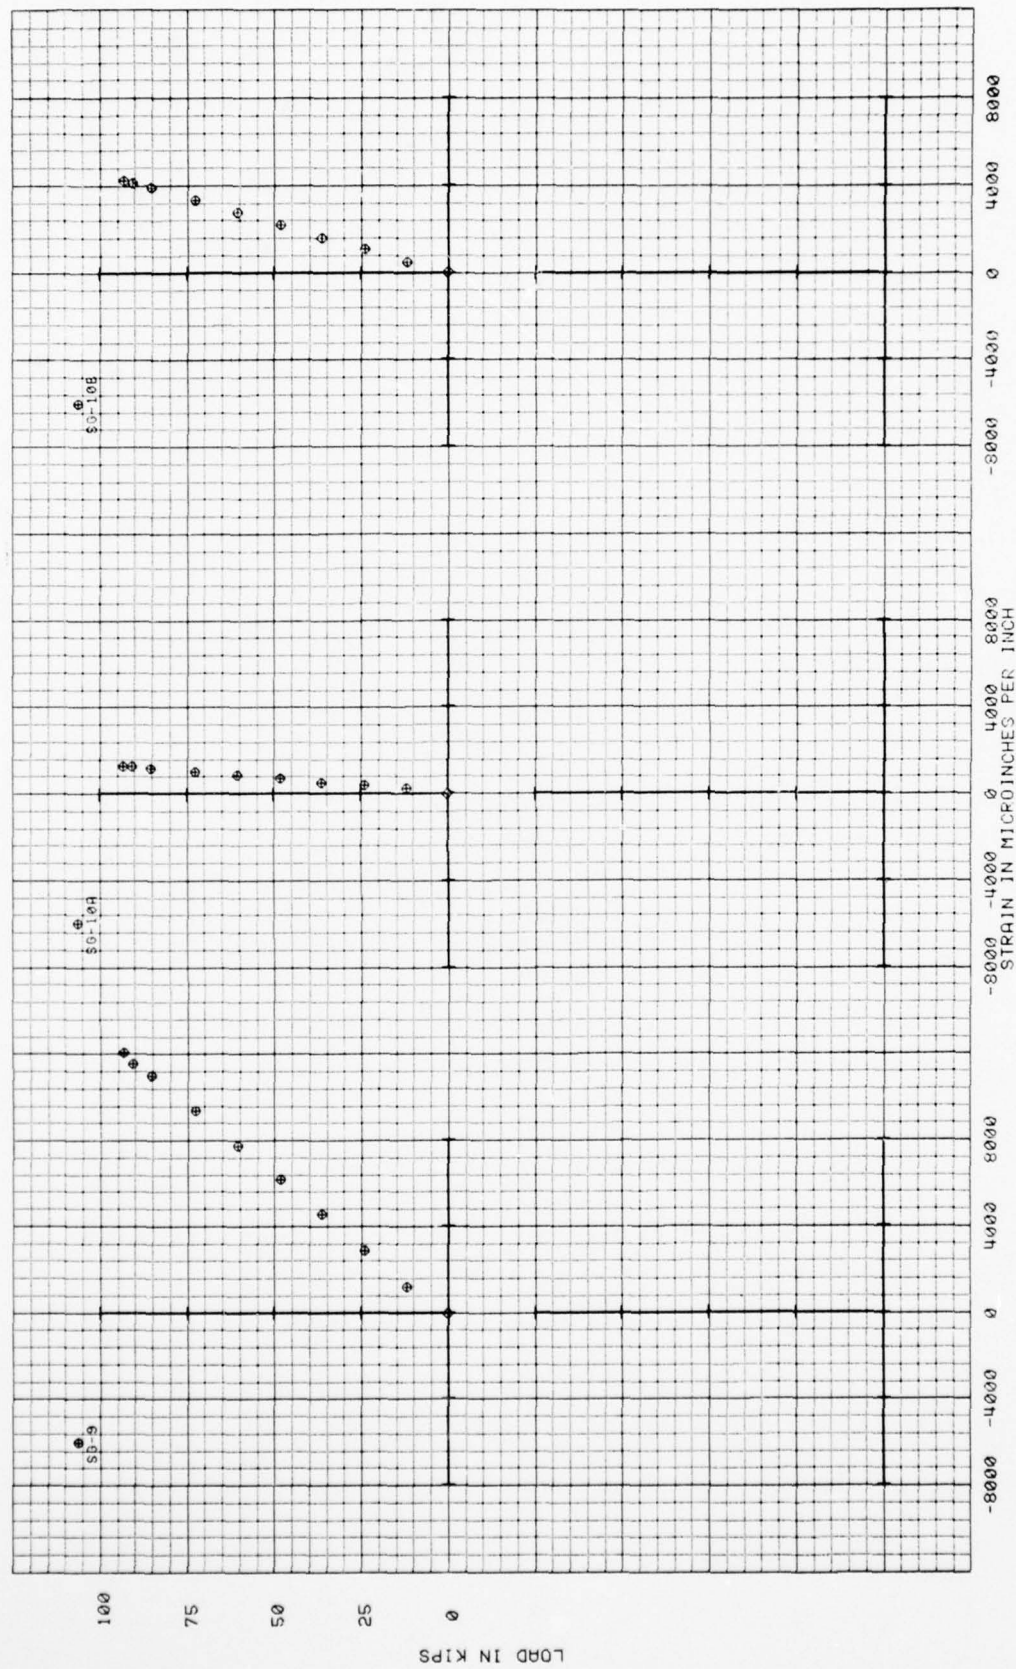
FIGURE B-19 Continued Strain Gage Data 75T060106-1005

1/2 Laminate 2.5 Dia Damage Hole

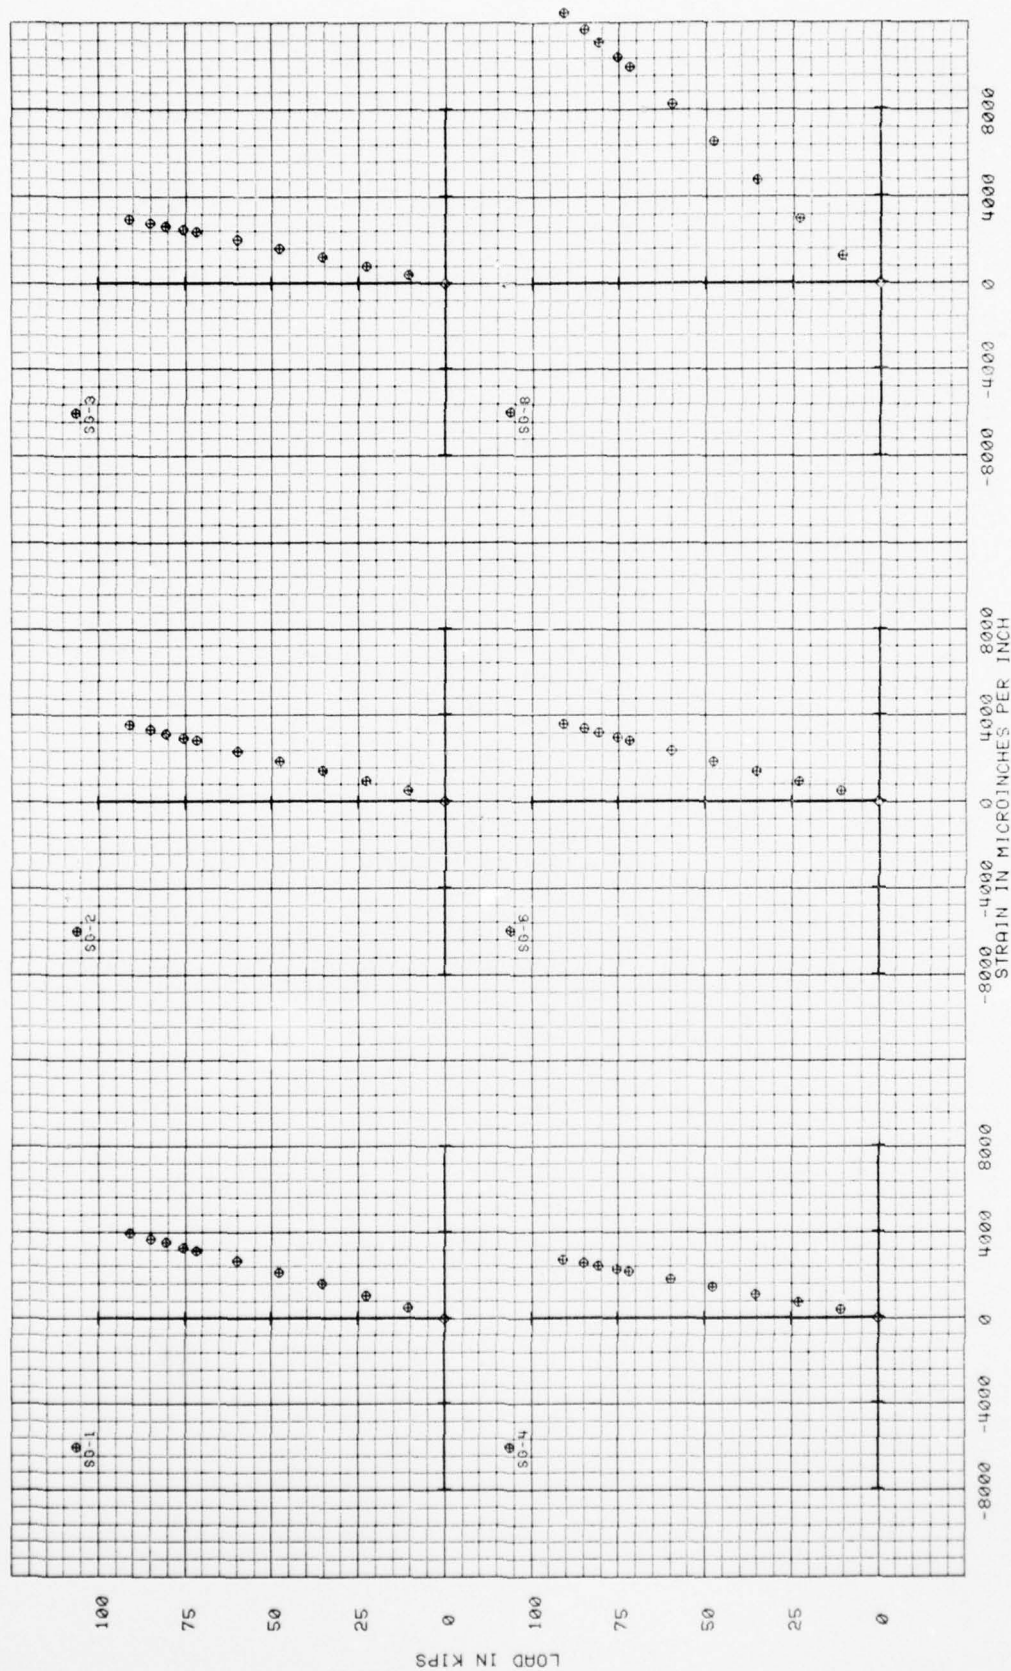
FIGURE B-20 Strain Gage Data 75T060106-1007 No. 1  
1/2 Laminate 2.5 Dia Damage Hole

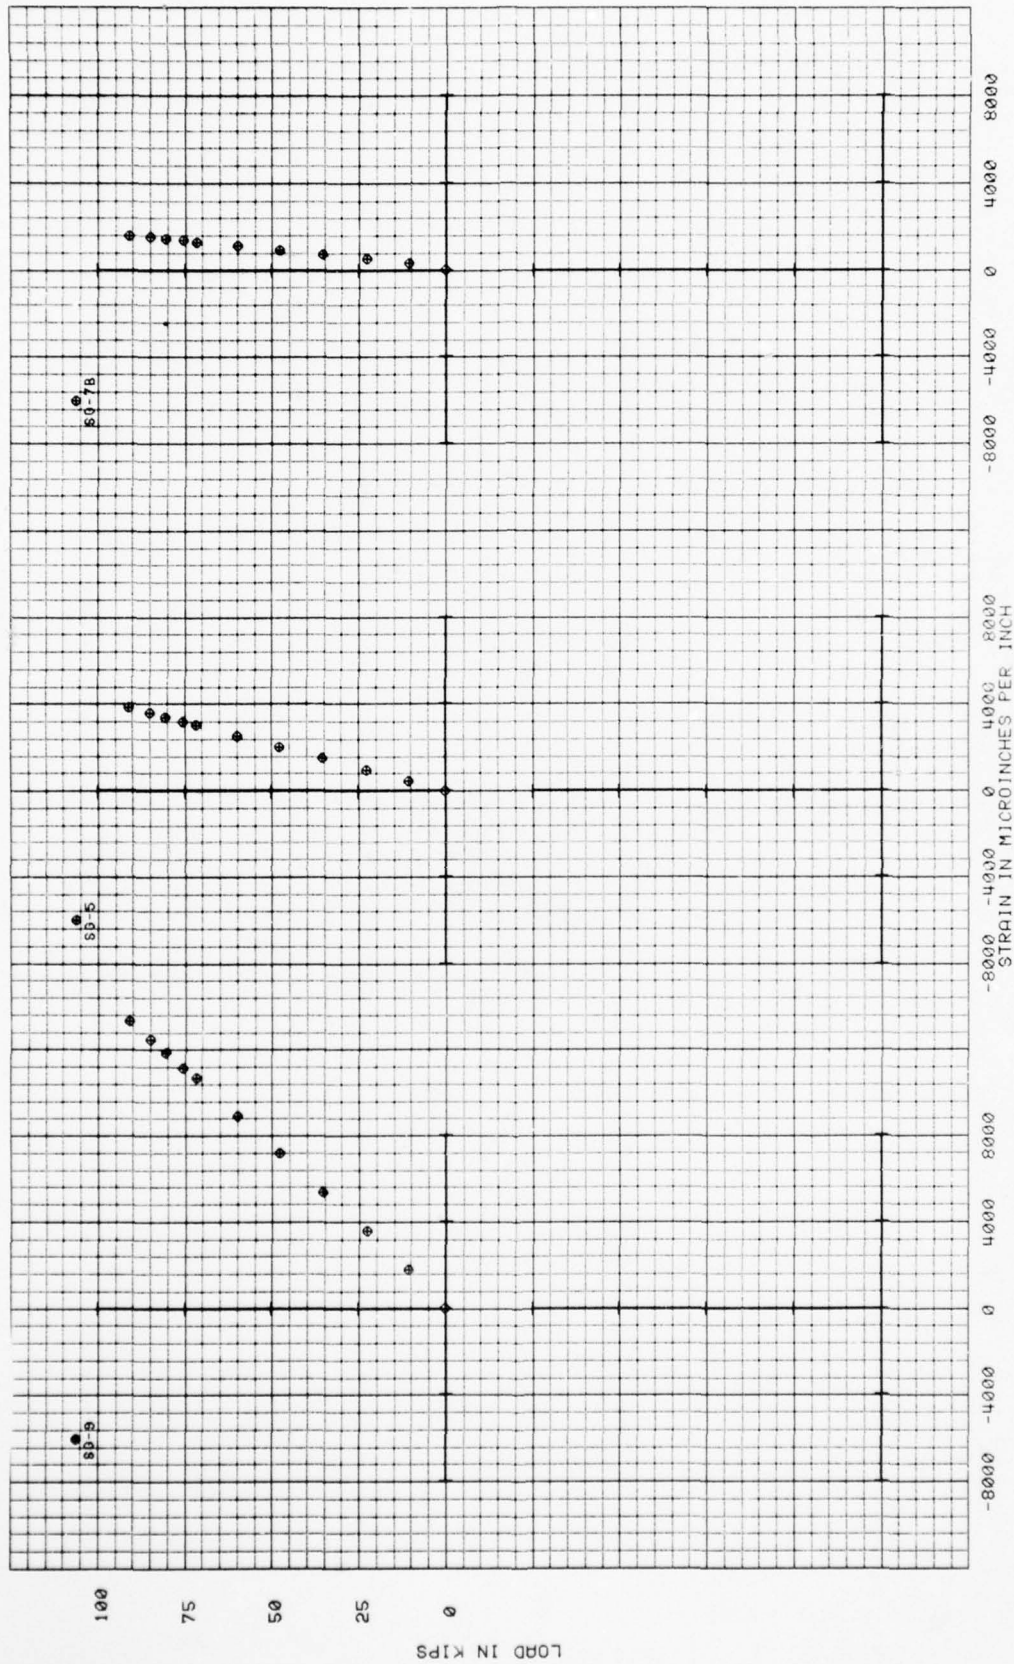
FIGURE B-20 Continued Strain Gage Data 75T060106-1007 No. 1  
1/2 Laminate 2.5 Dia Damage Hole

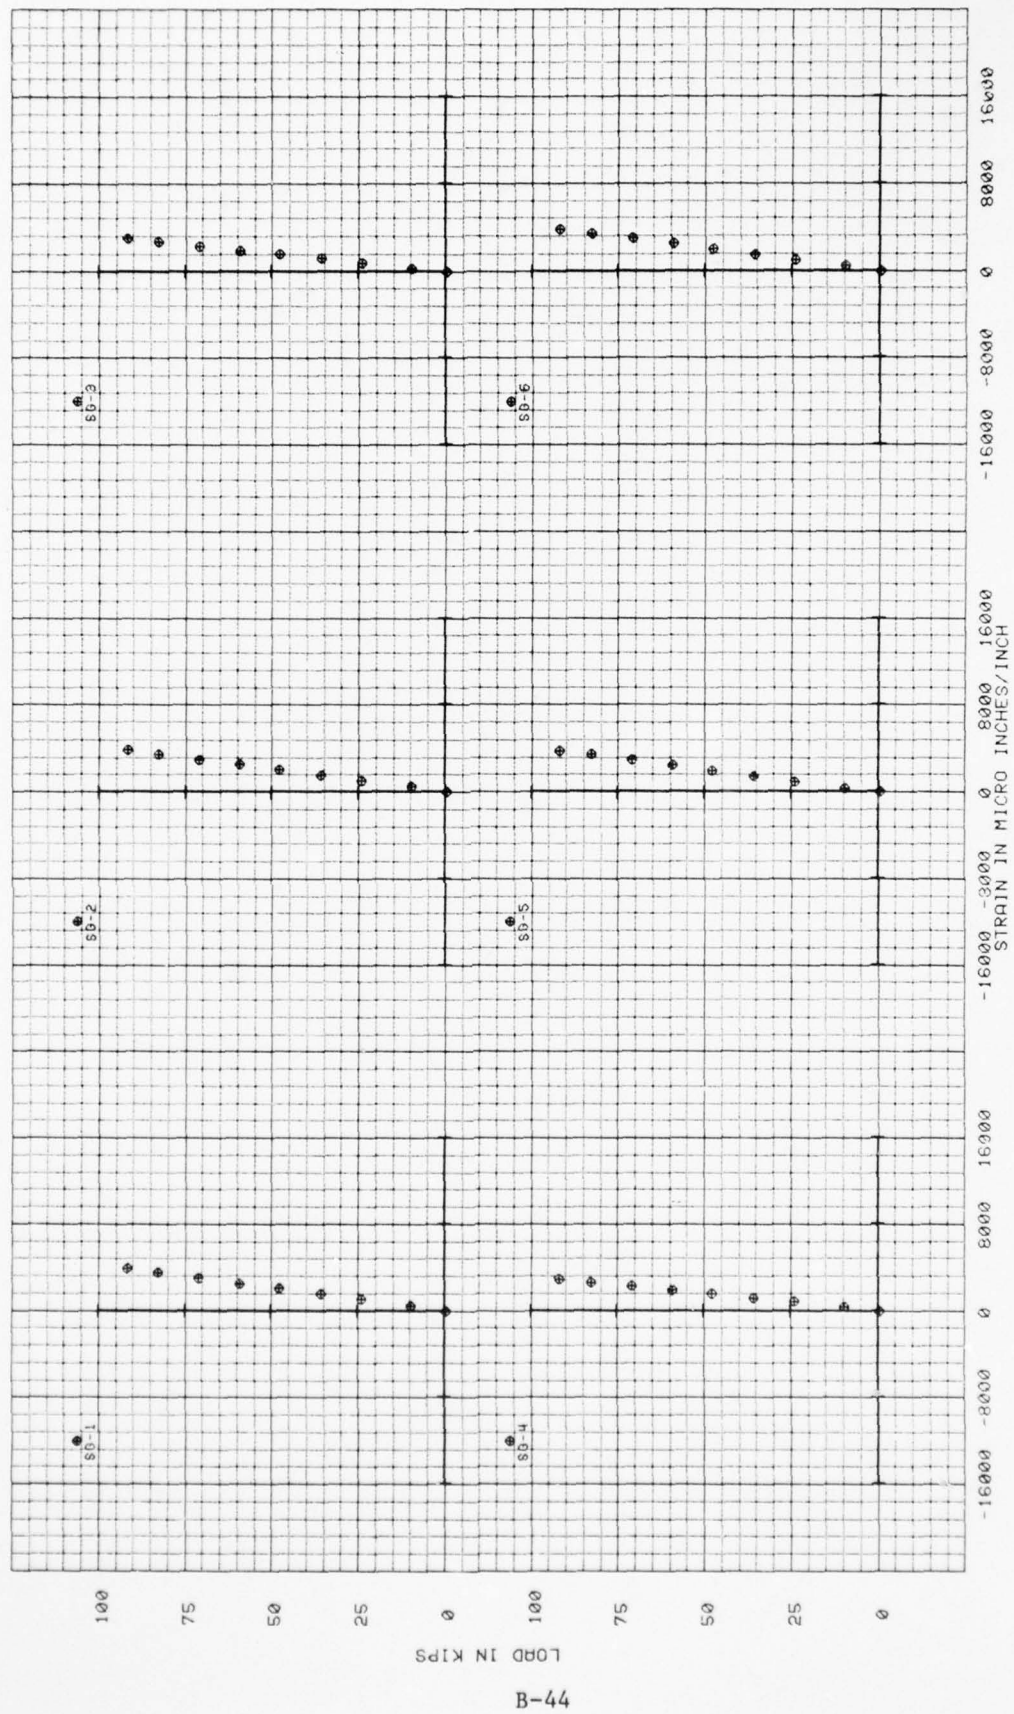
FIGURE B-21 Strain Gage Data 75T060106-1007 No. 2  
1/2 Laminate 2.5 Dia Damage Hole

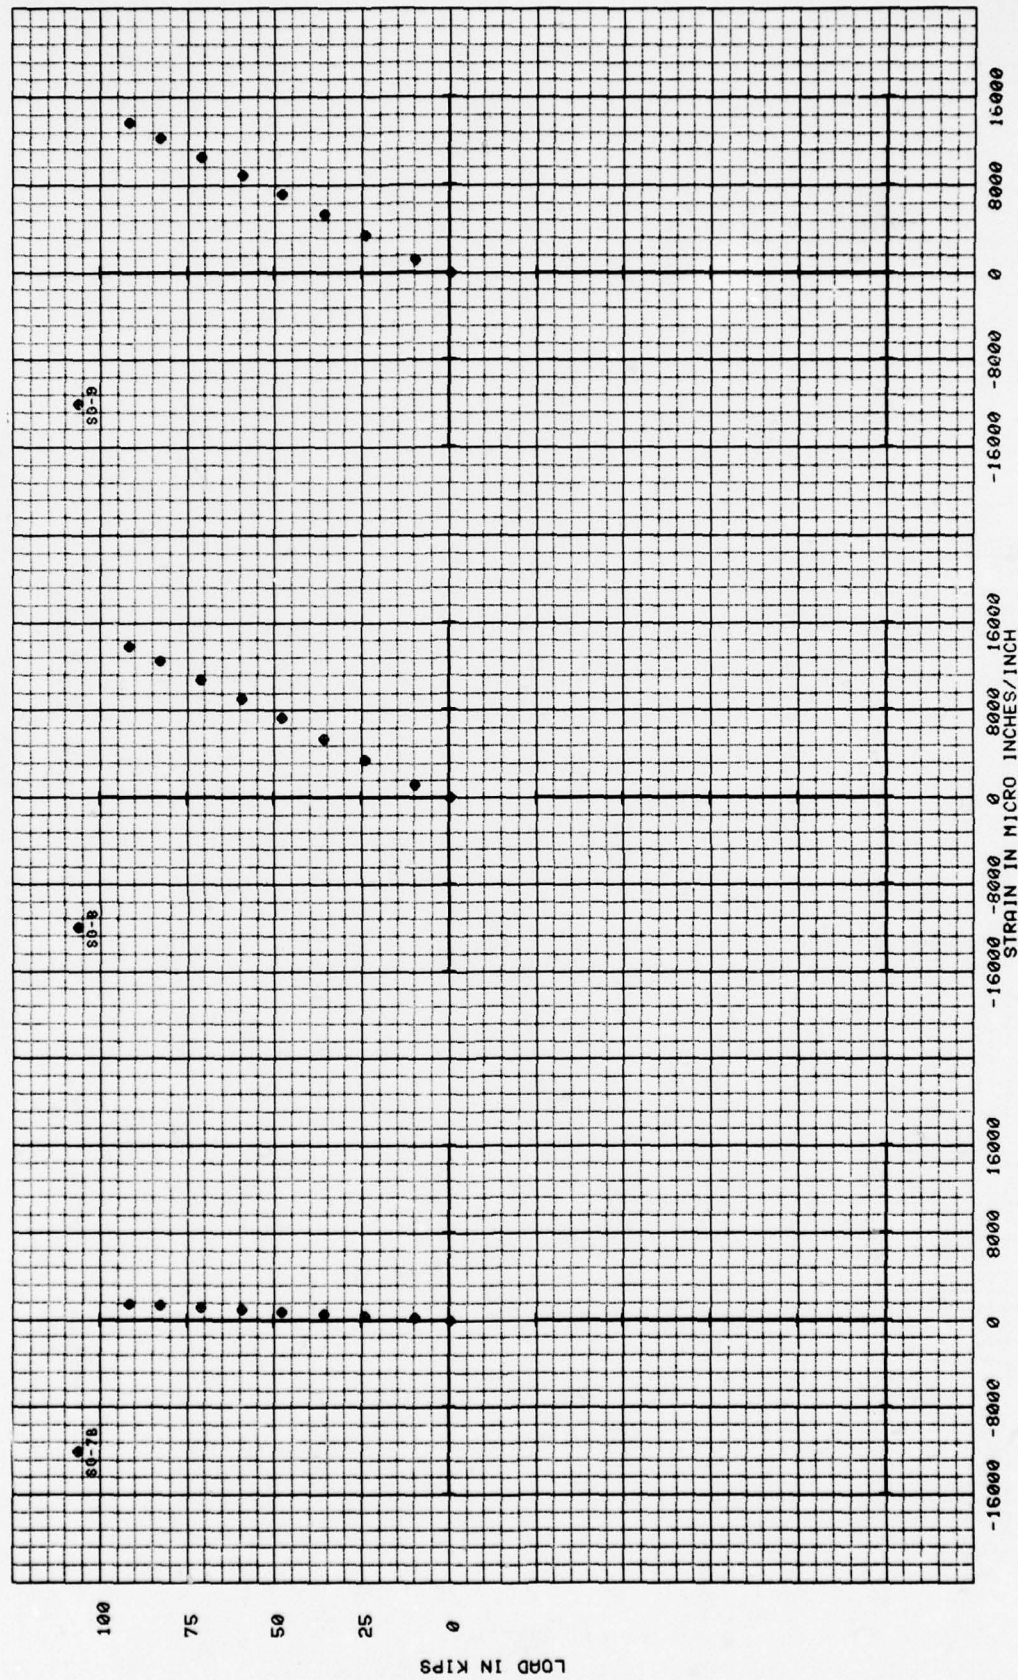
FIGURE B-21 Continued Strain Gage Data 75T060106-1007 No. 2  
1/2 Laminate 2.5 Dia Damage Hole

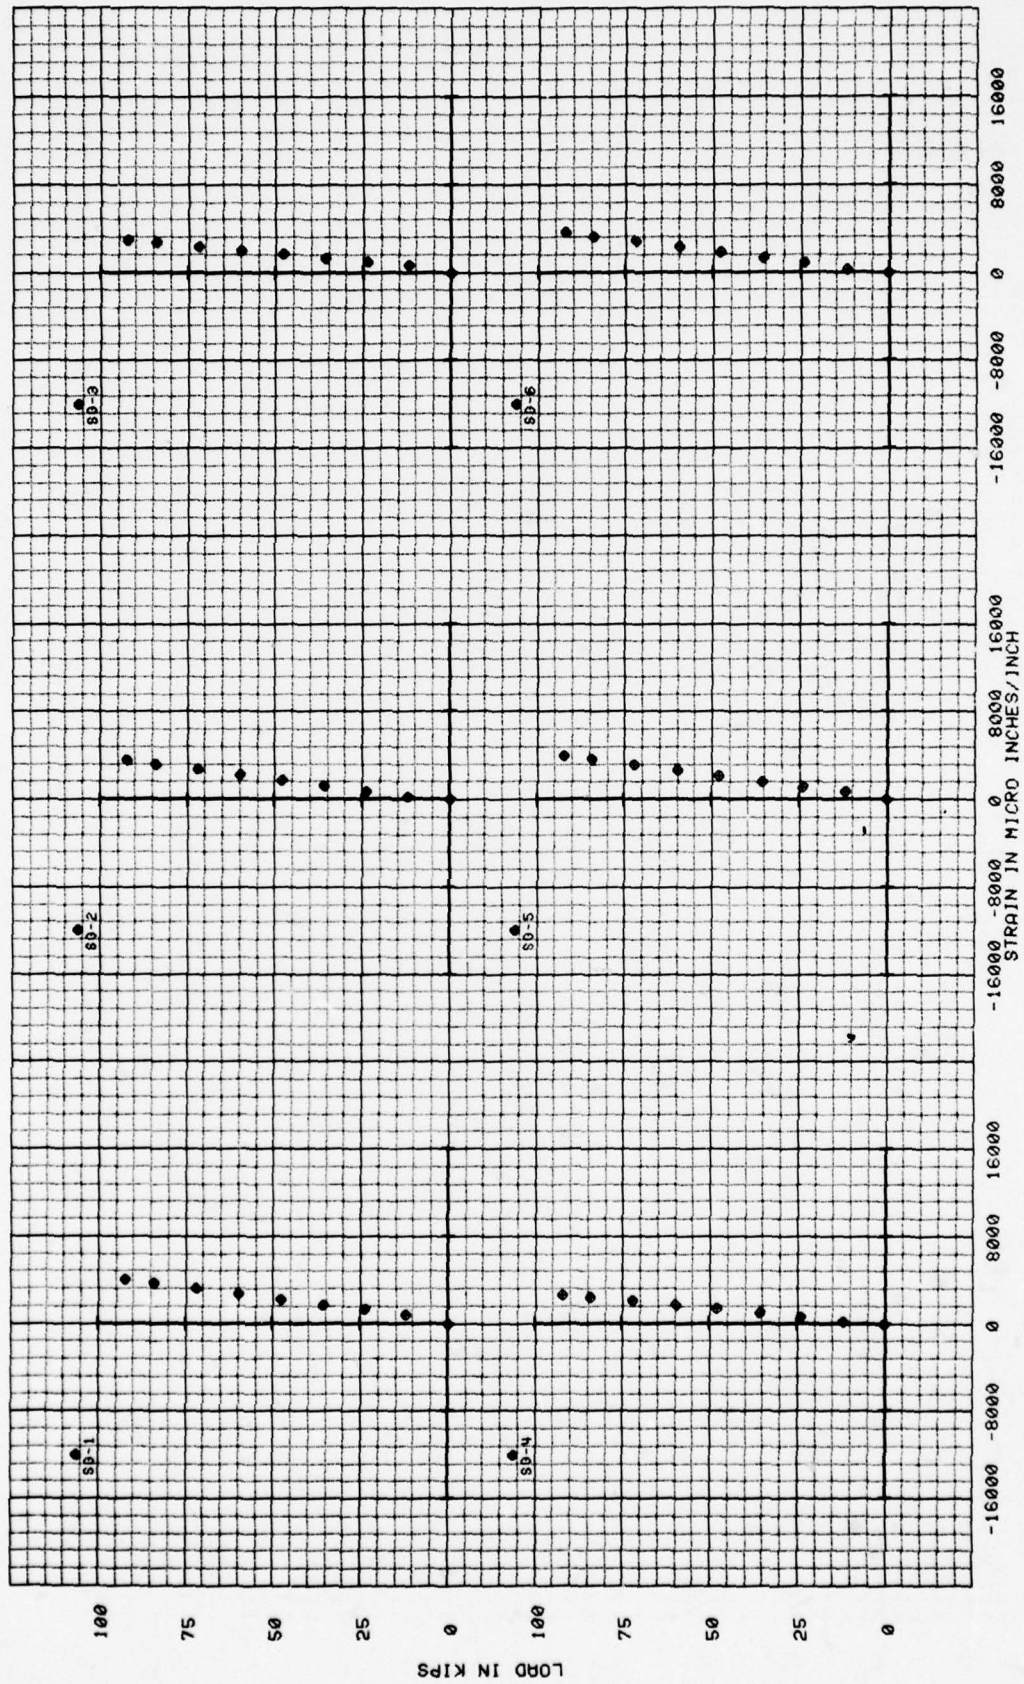
FIGURE B-22 Strain Gage Data 75T060106-1017  
1/2 Laminate 2.5 Dia Damage Hole

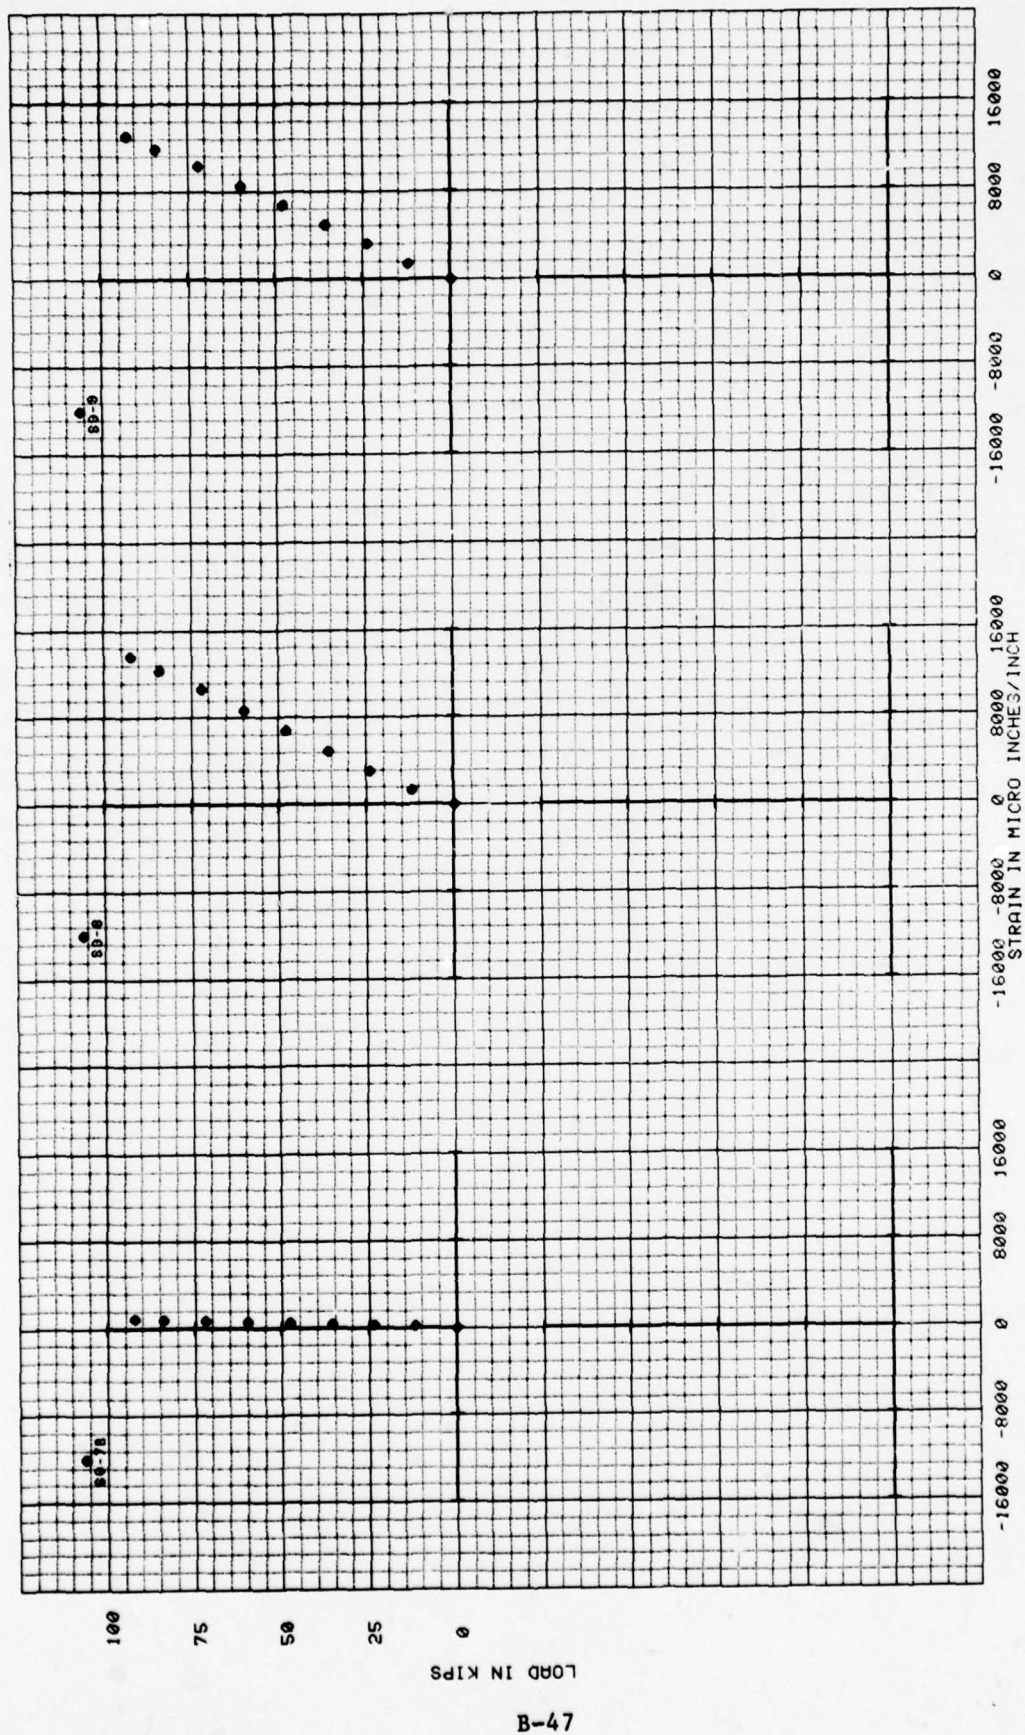
FIGURE B-22 Continued Strain Gage Data 75T060106-1017  
1/2 Laminate 2.5 Dia Damage Hole
